ELCT-ULANGA KILOMBERO DIOCESE
TUMAINI LUTHERAN SEMINARY

A BRIEF REPORT OF COMPLETION OF DINING HALL

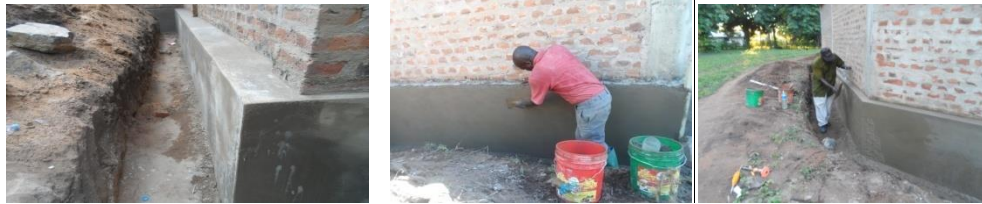
Plastering of the foundation also has finished as it is shown in the pictures below.

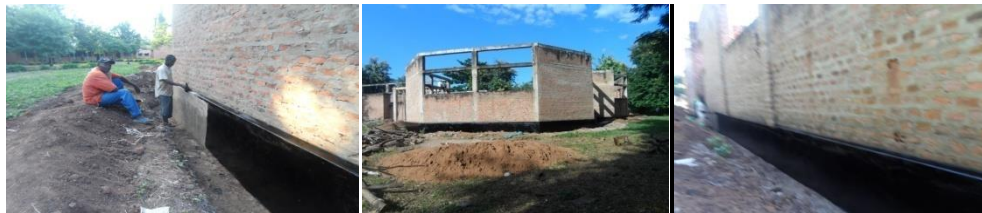
The work of painting foundation with bitumen is also finished. See the below.

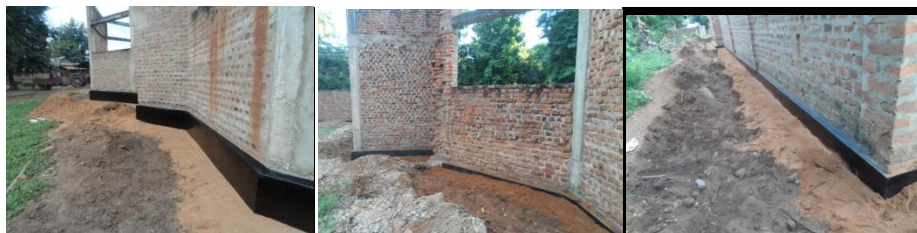
The work of refilling sand in the foundation is still continues. Outside the hall is finished, remains inside the hall where the work of refilling continues, it is our hope that two or three days later will be finished. See also the picture below.

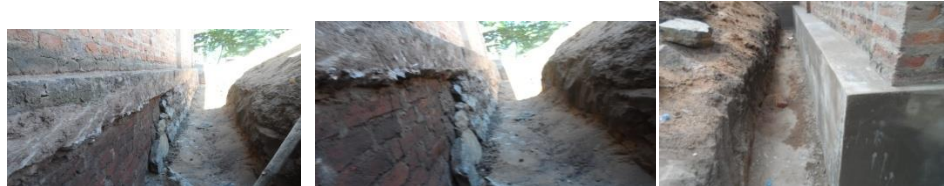
- One of the walls was built outside the foundation. To correct this mistake another foundation was built to support the wall which needed **one trip of natural stones**. Labour charge for this work is **Tsh.150,000/-** equivalent to **US Dollar 72**. See the pictures below.

Decision: The Committee accepted the request from the Tenderor for these extra works.

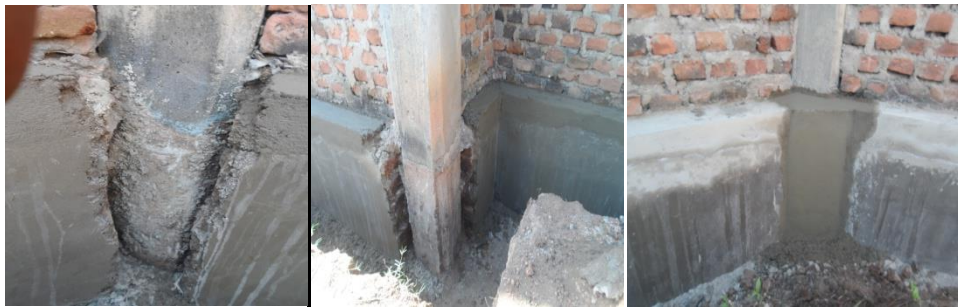
- Tearing down the hard floor to smooth plastering inside the dining hall. Labour charge for this work is **Tsh.200,000/-** equivalent to **US Dollar 96**.
- To fill the gaps between the walls and pillars of the building by casting the concrete Labour charge for this work is **Tsh.300,000/-** equivalent to **US Dollar 143**. See the pictures below.

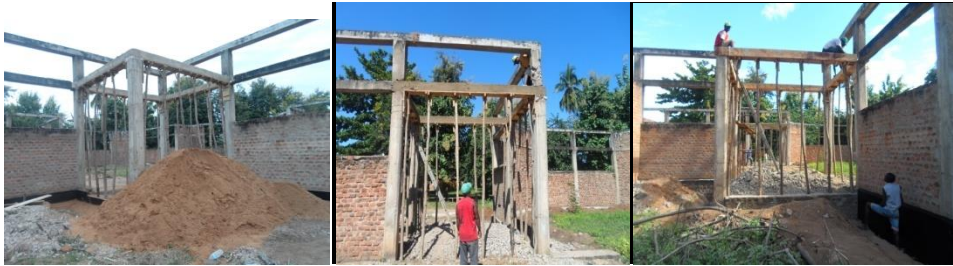
All of these works have been done well and are finished as pictures below shows.

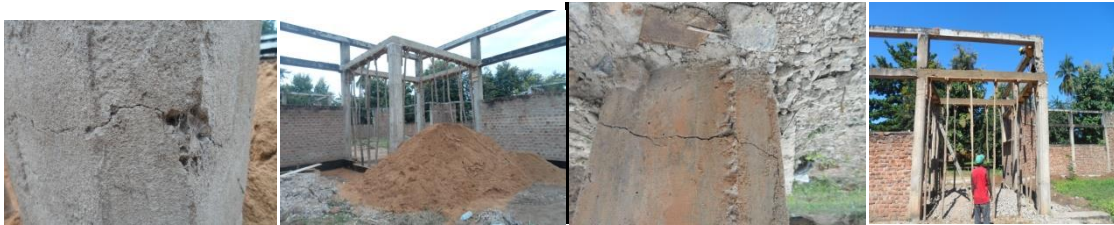
Two pillars got problems (have cracks) one from each side as it is shown in the pictures.

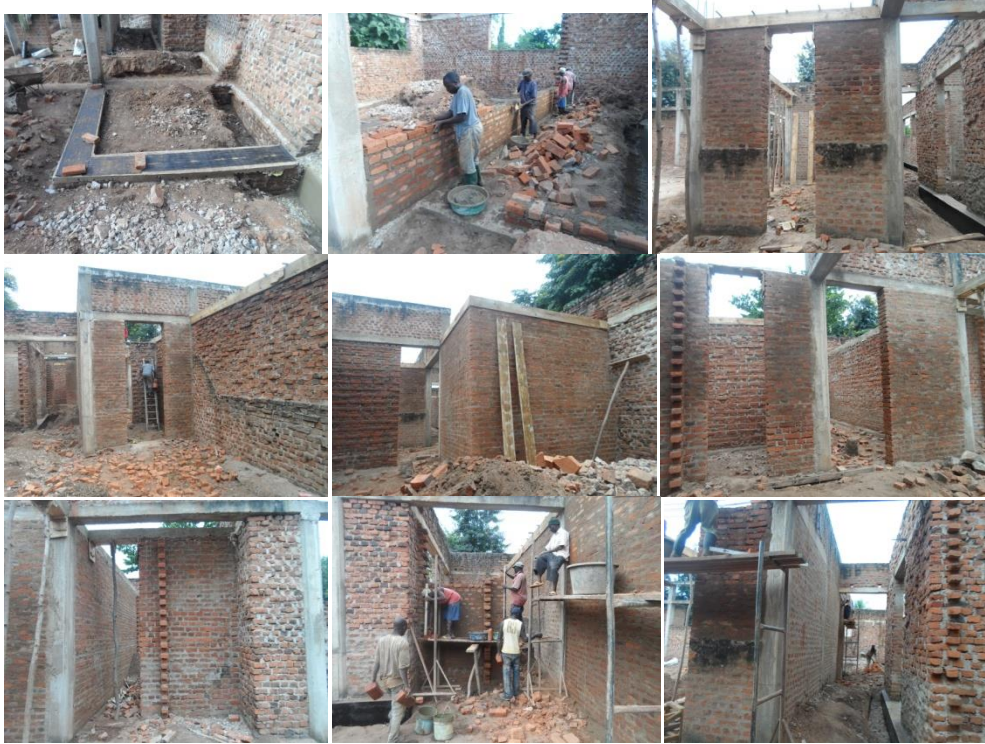
All these works also have been done well except for tearing down the wall, which according to the Tenderor it was mistaken overlooked. So there was no need of breaking down the wall. The pictures below support the above explanation.

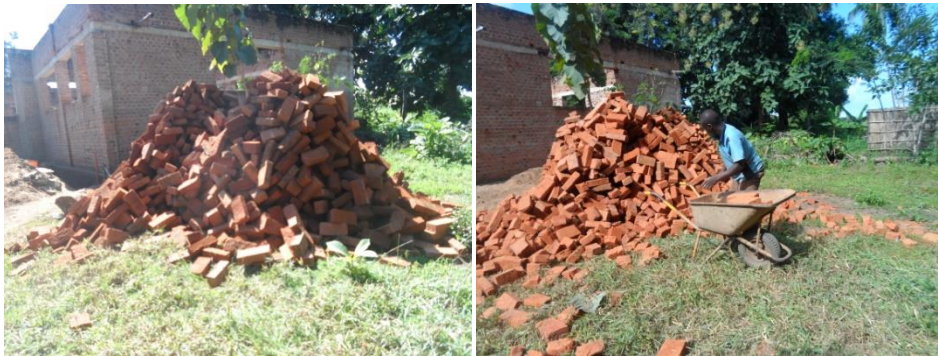
In the construction of the walls there was a shortage of 5000 bricks which costs **Tshs. 500,000/-** equivalent to the **USDollar 239.**, and the Tenderor got permission from the Committee to find the needed bricks in order to finish the walls.

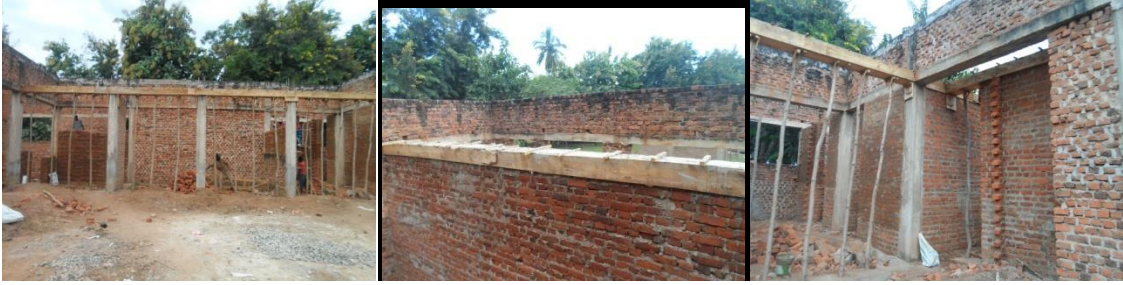
The work of ring beams is going on as it is shown in the pictures below;
